ENGINE - GASOLINE

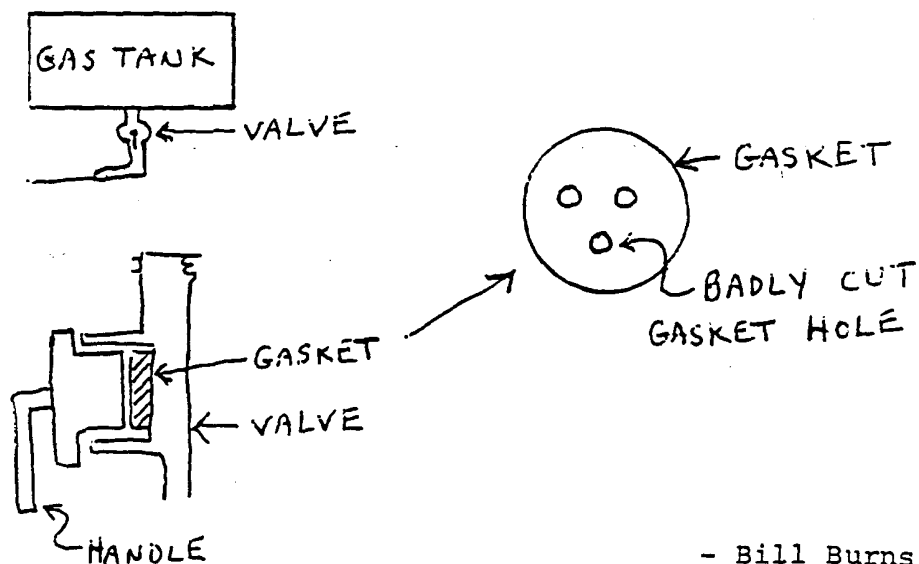
I have solved my engine problem! Basically, the engine - a gasoline model - ran for 30-40 minutes then backfired through the carb. I checked the gasoline, checked the filters, valves, electrical system, etc. The most puzzling event was a 10-minute shut down, and it would run for another 30 minutes; plus or minus. I also checked the compression - hot and cold.

Finally, I removed the valve on the gas line at the tank and found a gasket poorly cut; partially covering the fuel port. I checked the valve, reworked the gasket and valve, the engine ran 3 hours without a problem, and has run well since.
