RUDDER REPAIR

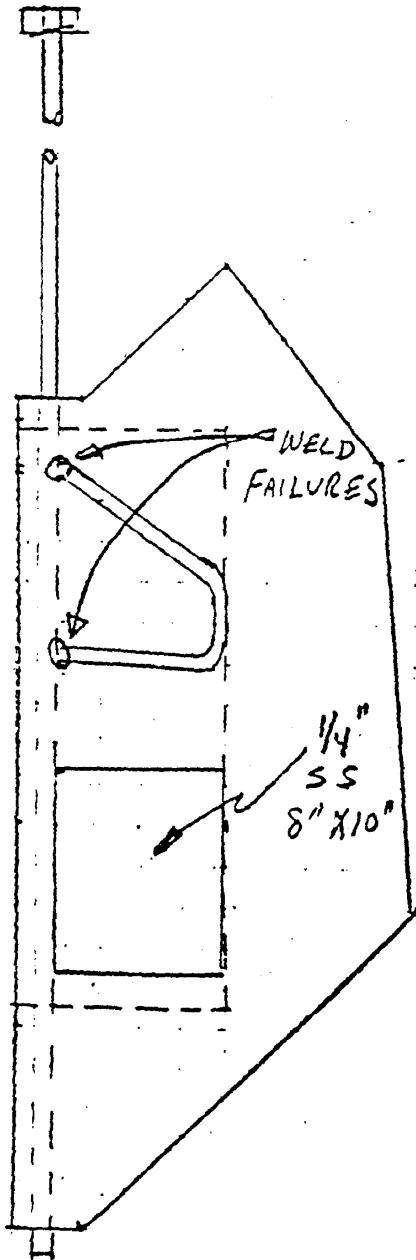
Our rudder problem was indicated by a progressing offset of the tiller with the rudder in a neutral position. We had to cut the fiberglass away (dotted line) to reveal the failed weld connections, as the drawing (to scale) shows. We had the rod re-welded to the rudder post. For good measure, we had a $\frac{1}{4}$ " stainless steel 8"x10" plate also welded to the rudder post. We then filled the void with a sand and resin mix, and fiberglassed and painted the rudder to complete the repair. The rudder is now much stronger than the original. The total cost was about \$70 for welding, fiberglass material, and the stainless steel plate.

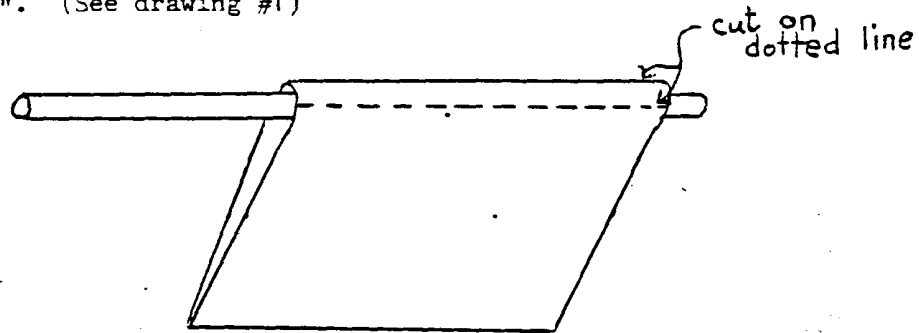
#1

With the rudder ashore we carefully made a cut on both sides parallel to the rudder shaft the full length of the rudder. This piece now came off as a "cap". (See drawing #1)

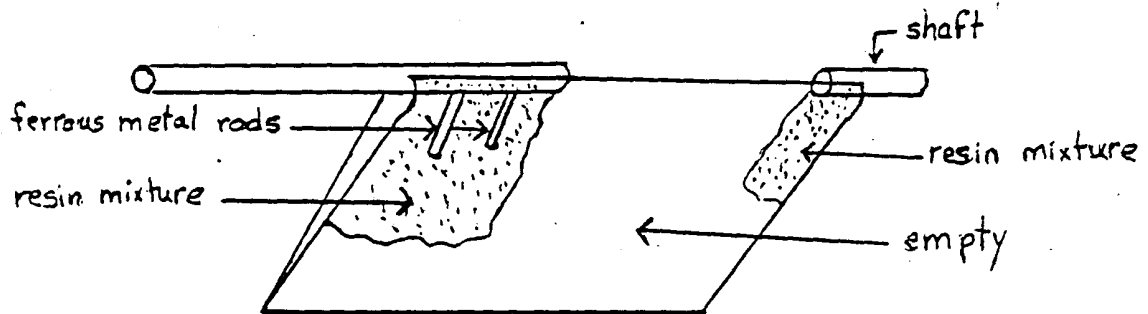
#2

With this "cap" removed we were surprised to see the construction. The shaft did not extend all the way through the rudder but was in two parts. The upper end extended approximately 18 inches into the rudder and was attached to two ferrous metal rods welded to it which were in turn embedded in a resin/fiberglass/sand mixture poured into the upper portion of the rudder. The middle of the rudder was empty. The lower end of the rudder held a 10 inch piece of shaft embedded in a resin mixture poured into the lower portion of the rudder. (See drawing #2)

"X-ray" view with cap removed

Our problem had been with the ferrous metal rods, of course. The first one had broken loose from the shaft and the lower one had begun to work in the resin mixture.
