ENGINE - DIESEL

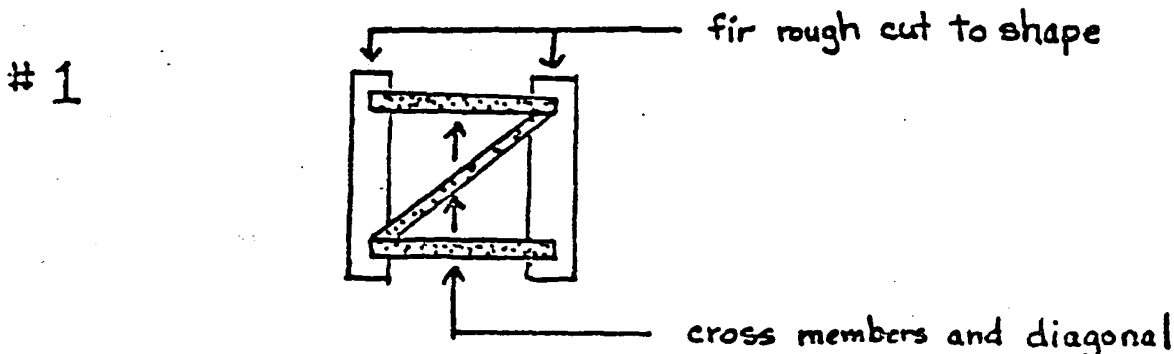
We roughcut to shape two 2x6 pieces of fir, using the plumb line and engine brochure information to determine their dimensions. We squared these up with cross members and a diagonal temporarily tacked to it. See figure #1. The base of the bed where it rests against the hull does not have to be too tight or too accurate.

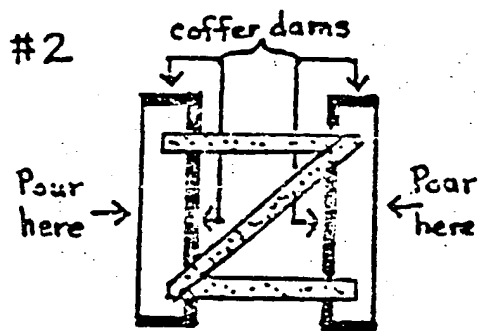
TOP VIEW

On the inside edges and ends of the bed we built a coffer dam against the hull with fiberglass and resin. Using a mixture of resin, microballoon, and Cabocil, we poured this on the outside of the bed so that it ran under the roughed-in wood form to make a seal between the roughed-in bed and the hull. The mixture must be thin enough to pour

and run under the wood. See figures #2 and #3.

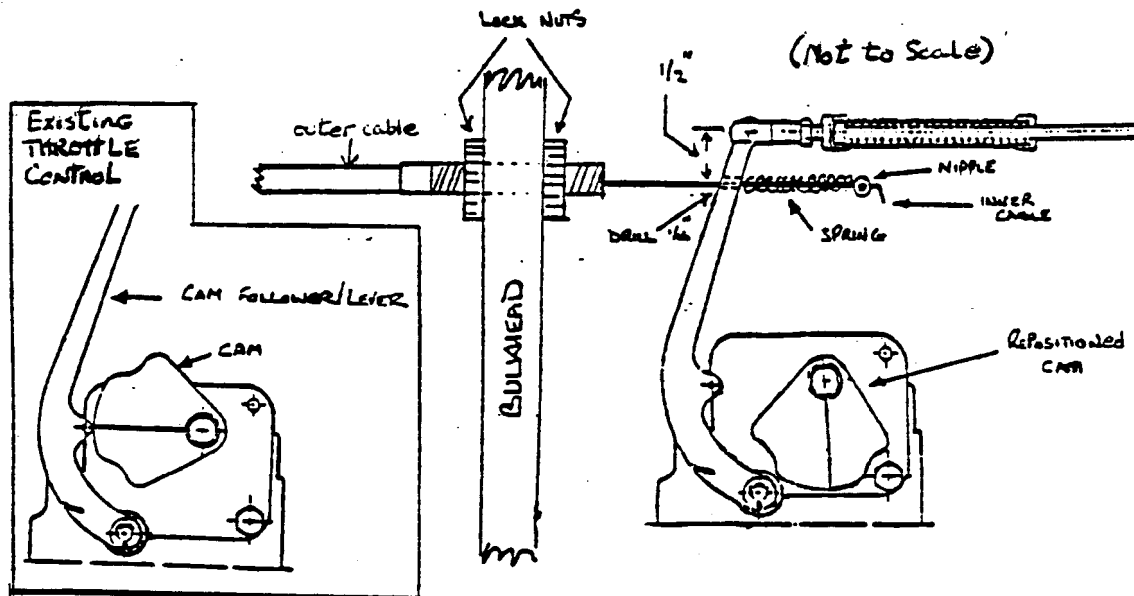
Investigation of the linkage to the throttle showed that the throttle was closed by a cam operating from the starboard side of the engine/gearbox, and opened by a spring on the cam follower-lever. The cam, which is on a taper, was moved around on its shaft so that it no longer operated the lever, and then refixed. (Thus, it can be restored to normal operation in the event of a cable failure on the remote unit.) I then drilled a 1/16" hole, 1/2" below the clevis pin in the lever, and passed the inner of the remote cable thru this hole; the outer being fixed using the plastic threaded connector into the removable bulkhead aft of the engine. The inner cable then had a compressable spring and a brass nipple to retain it and prevent slackness.

I can now control engine revolutions and prop pitch separately. This makes KRICKA much better to handle in confined spaces, and I'm certain it is more economical now as I set the controls for optimum performance. The other lever and cable on the remote unit I have used to operate the decompression lever on the rocker cover. This entailed making several brackets and fittings -- sketches of which I will send to anyone interested. The actual control unit is screwed inside the port cockpit locker.

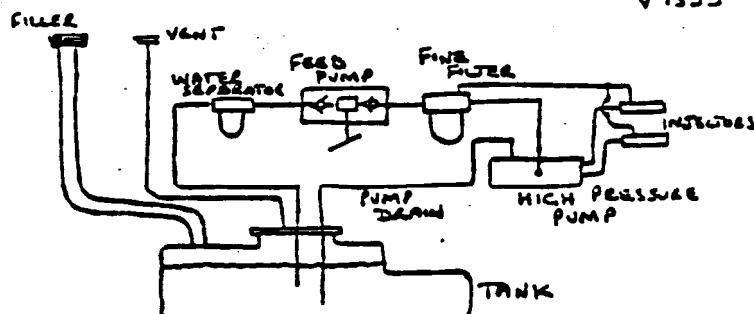
ORIGINAL VEGA/MD6A FUEL SYSTEM - CHELABELLE
V 1399

Many Vega owners have had starting problems due to air locks from joint leaks in the fuel system, because the Vega fuel tank is underneath the engine and any leak will have the effect of allowing air to be drawn into the system when the engine is stopped. The air finds its way into the body of the high pressure injection pump, where it becomes trapped behind the pistons, which have a very small displacement and they reciprocate without pumping anything.

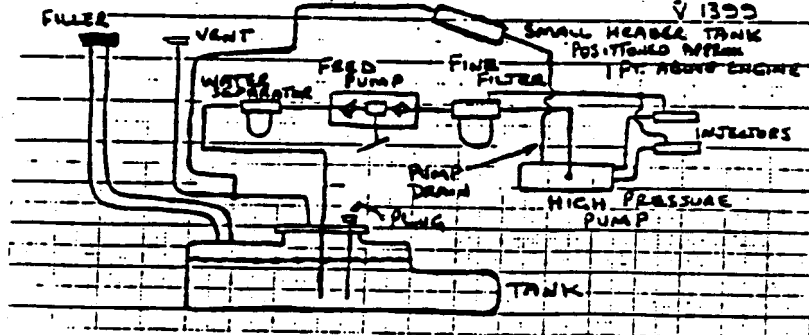
MODIFIED VEGA/MD6A FUEL SYSTEM - CHELABELLE
V 1399

To reduce the possibility of this happening on CHELABELLE, I have fitted a small reservoir positioned just inside the starboard cockpit locker, and piped the pump drain thru this reservoir so that when the engine is stopped the reservoir provides a positive pressure on the fuel system of at least $\frac{1}{2}$ p.s.i.

The tank return from the new reservoir is uppermost, and it drains back to the air space at the top of the tank (not under the fuel surface, which would create a syphoning effect). Access to the fuel tank is difficult, so I cut the vent hose, inserted a tee, and connected the tank return to that. The standard pump return is under the surface and therefore not reusable. Drawings of the original and modified system are shown below.

The reservoir was made from a piece of 28 mm copper tube, $\frac{1}{2}$ meter long, with reduced fittings at each end to 8 mm diameter. 8 mm bore, clear flexible hose was used to connect the reservoir to the pump and tee. This size of reservoir would replenish a leakage of 1/10 litre.
